Figure E-1: Looking upstream at Macallen Dam from downstream footbridge. Photograph taken 10/4/2013.

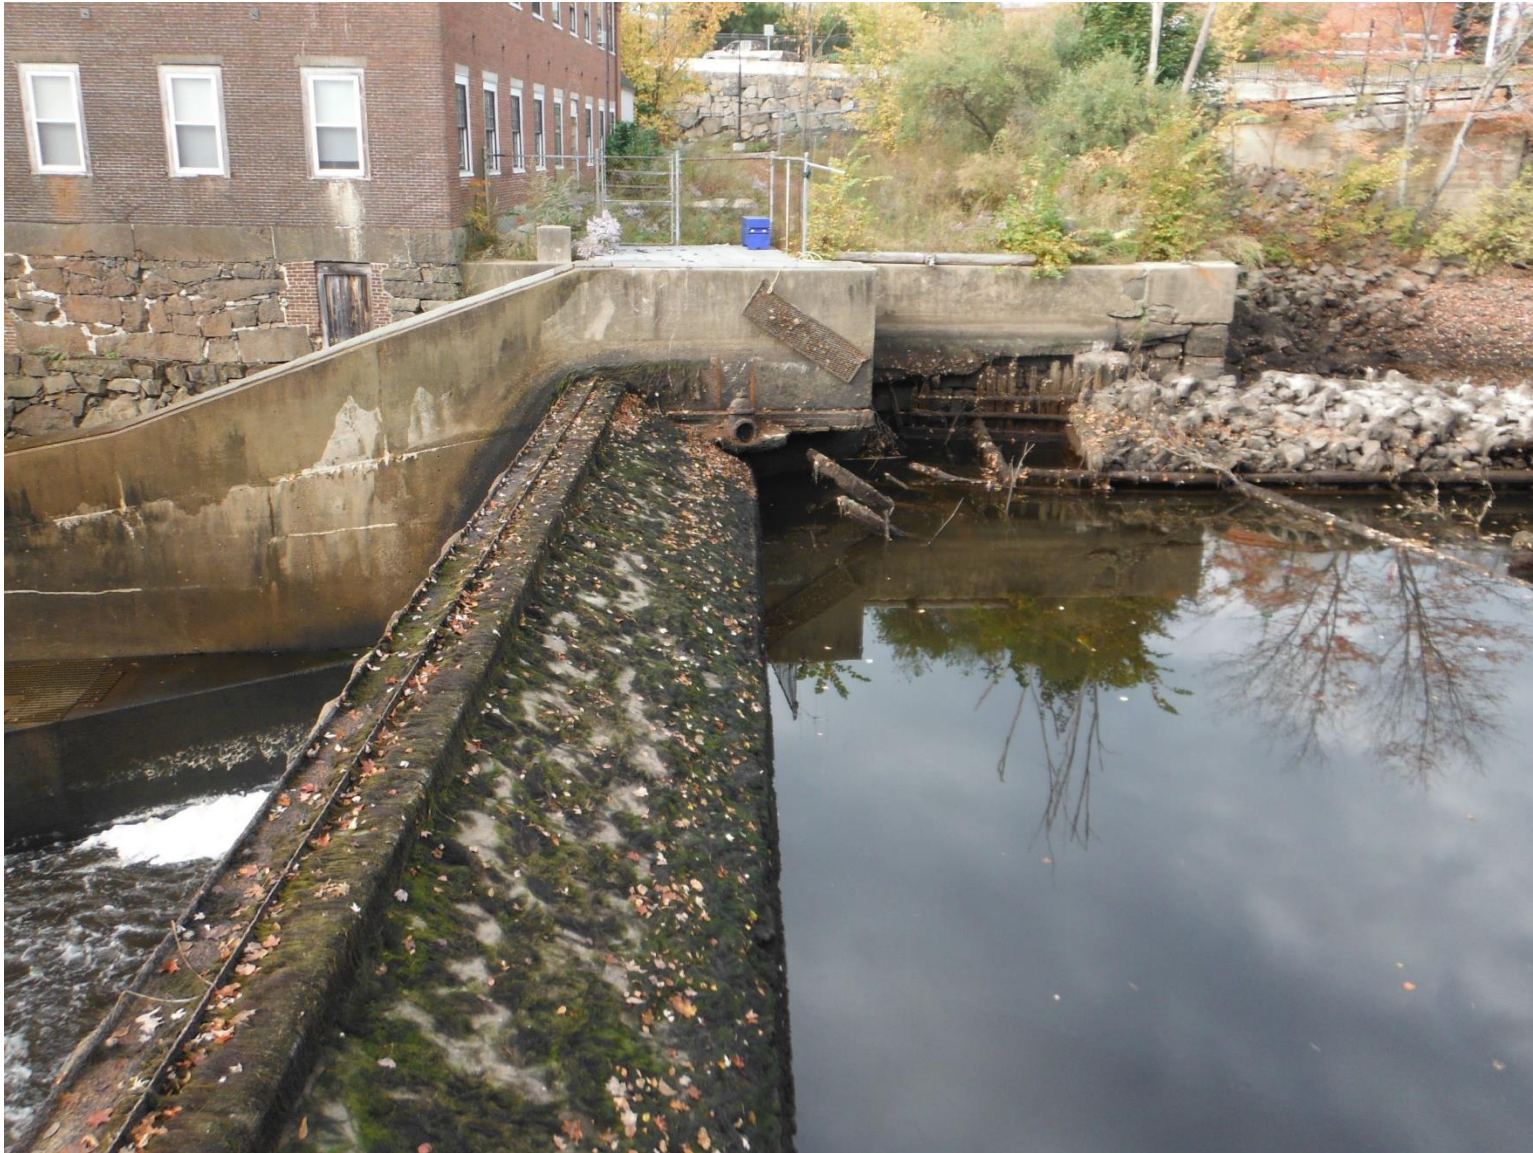
Figure E-2: Looking toward the right (west) abutment from the left (east) abutment. Photograph taken 10/4/2013.

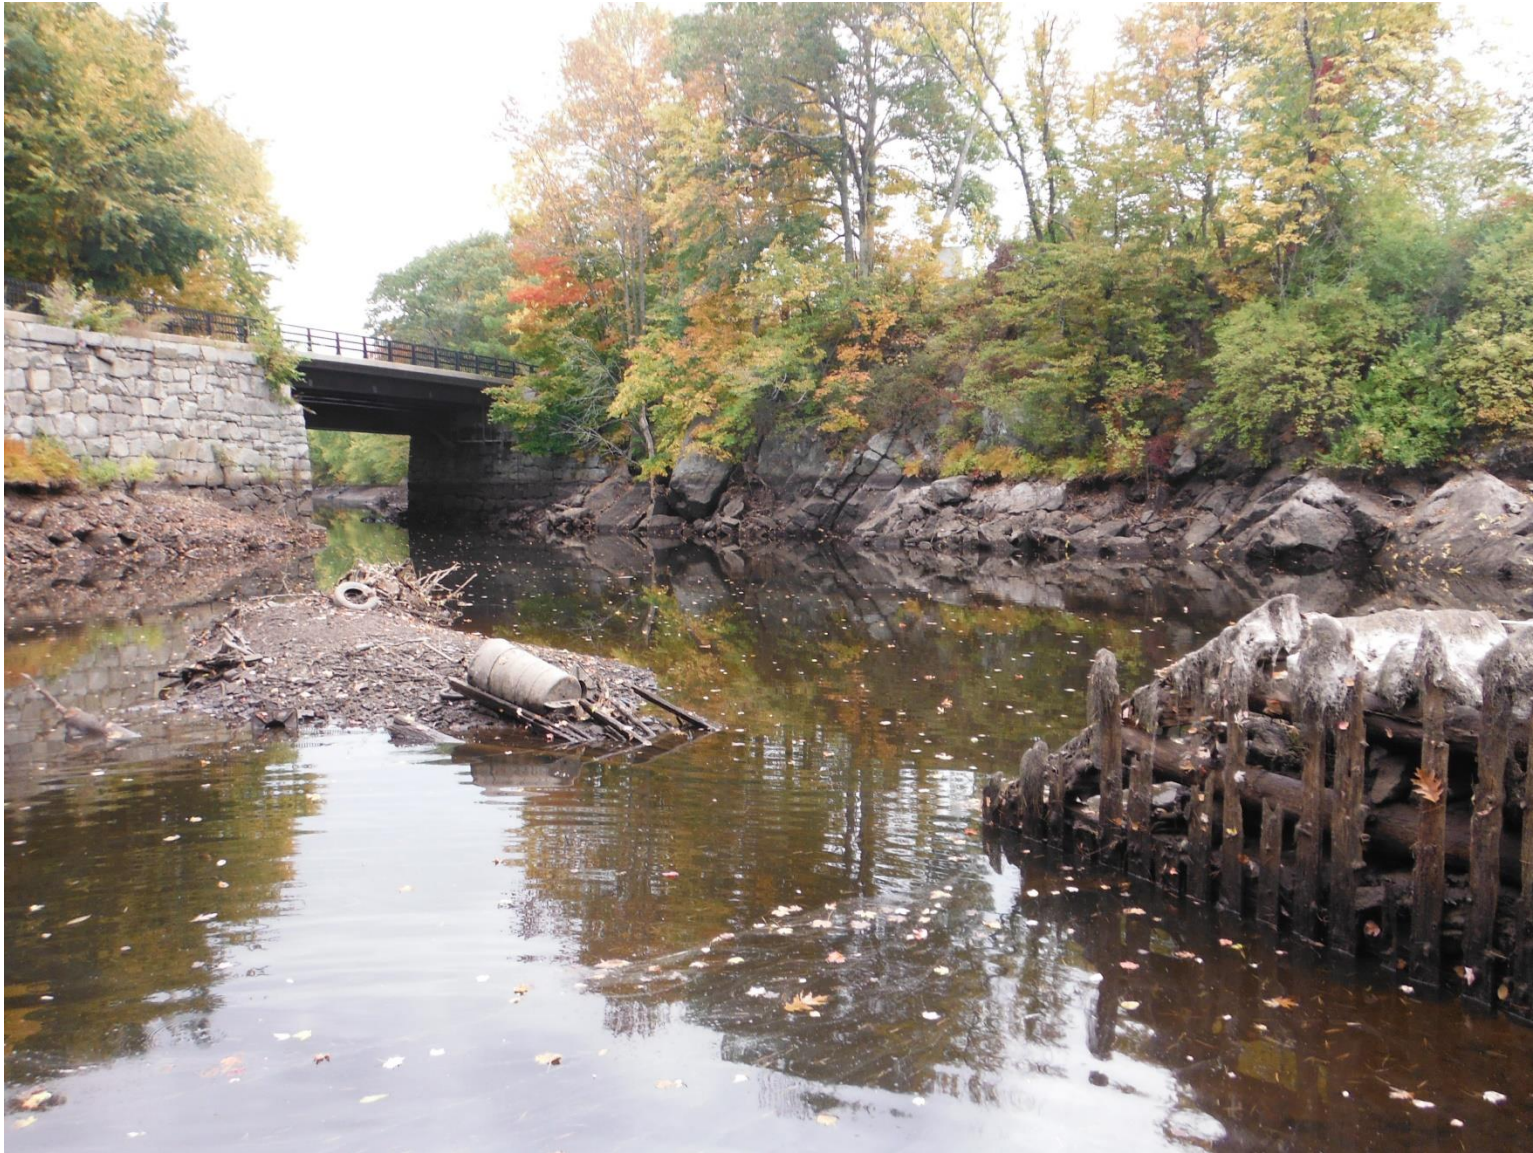
Figure E-3: View upstream toward the Veteran's Bridge from upstream of the dam's right abutment. Photograph taken 10/4/2013.

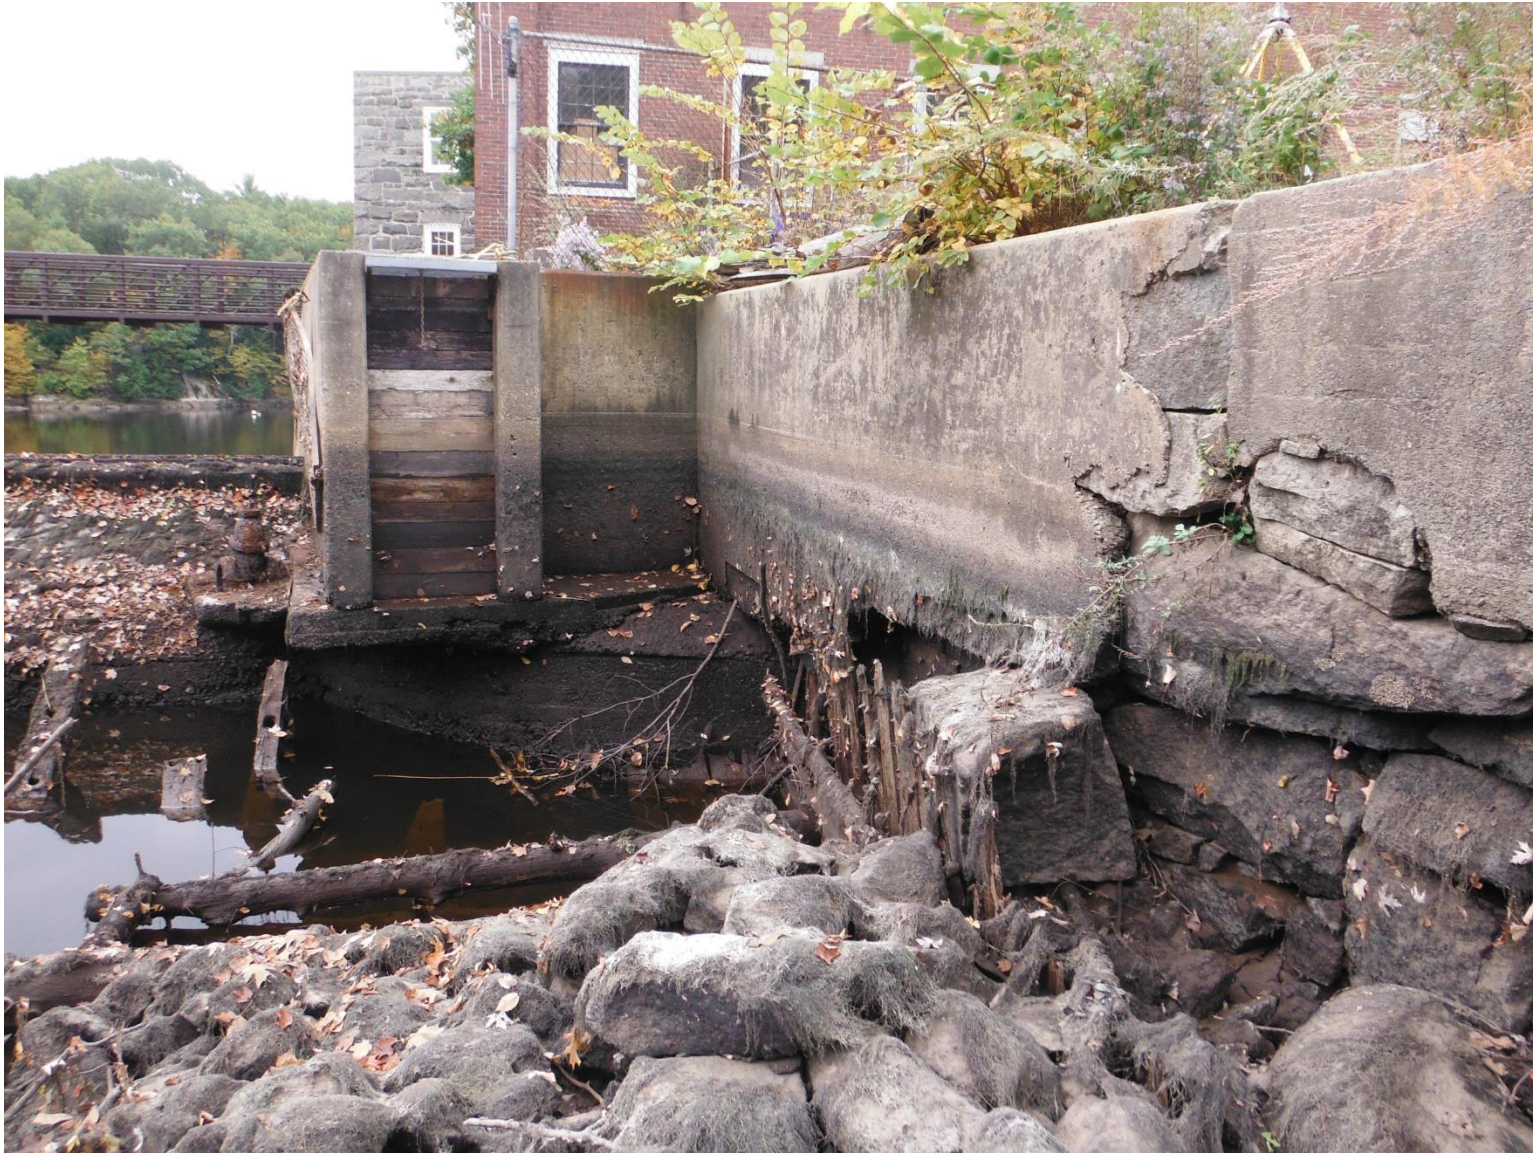
Figure E-4: View of the dam's right abutment, fish ladder and a portion of the legacy timber crib dam. Photograph taken 10/4/2013.

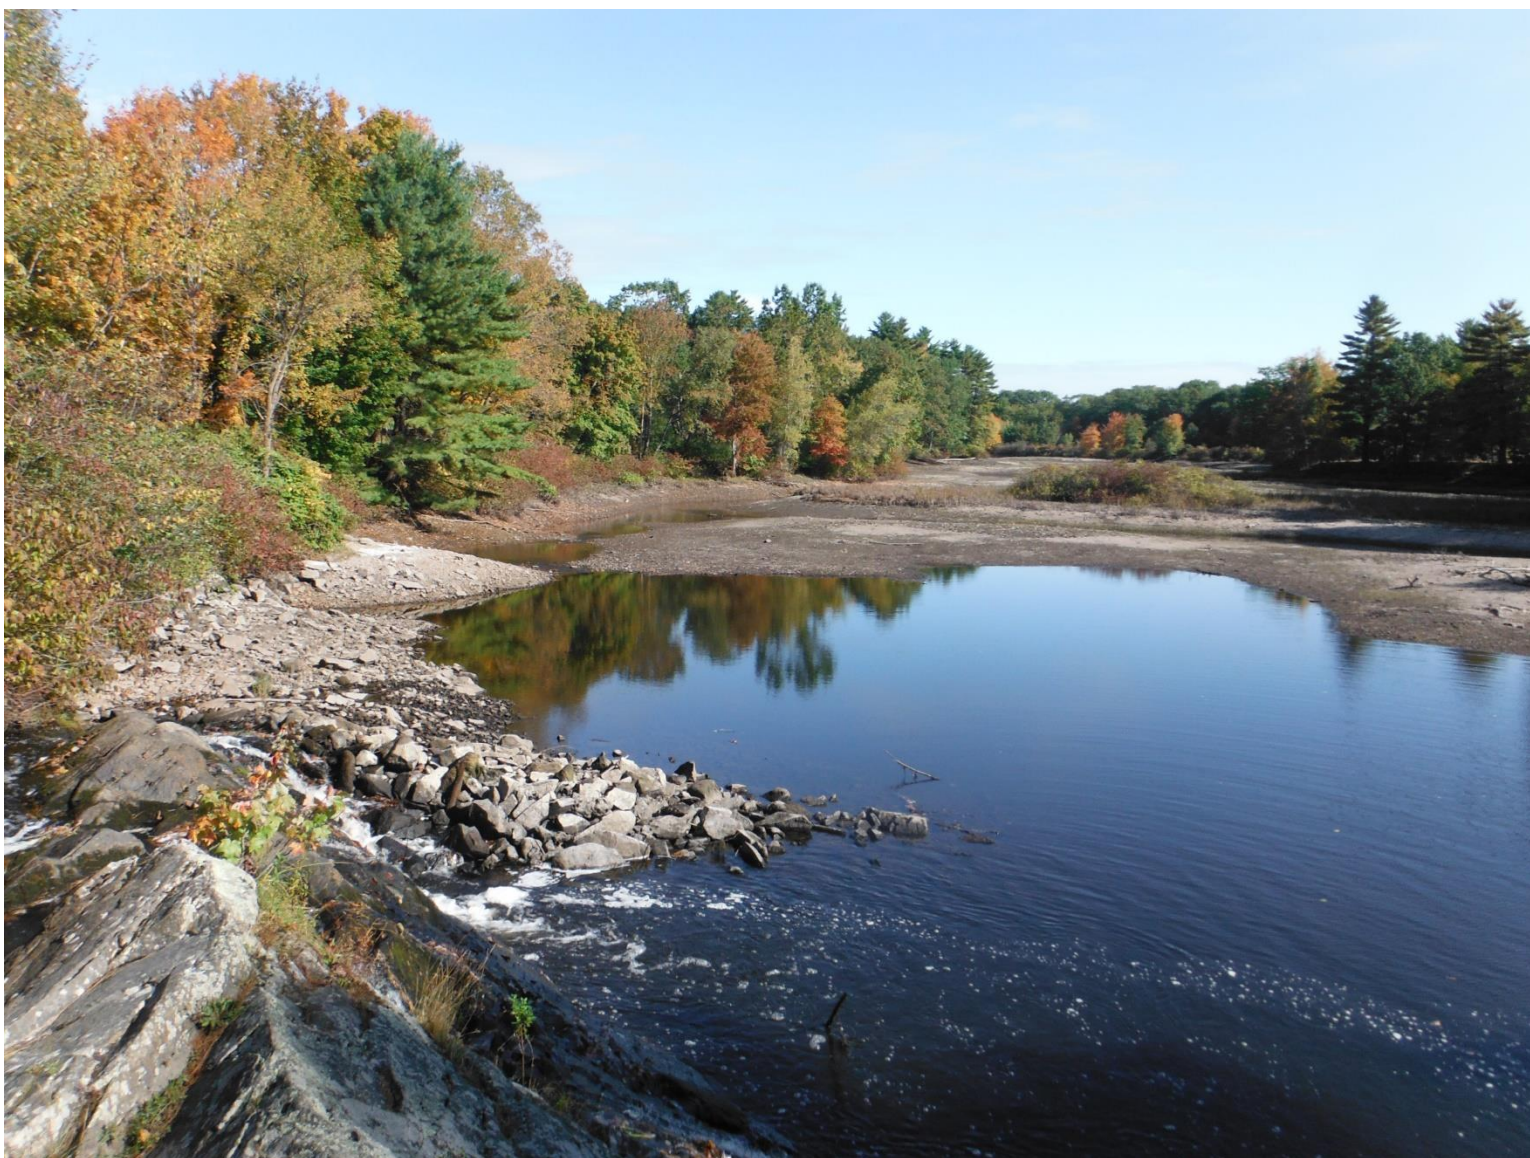
Figure E-5: View of Piscassic River from historic water works structure. Photograph taken 10/5/2013.

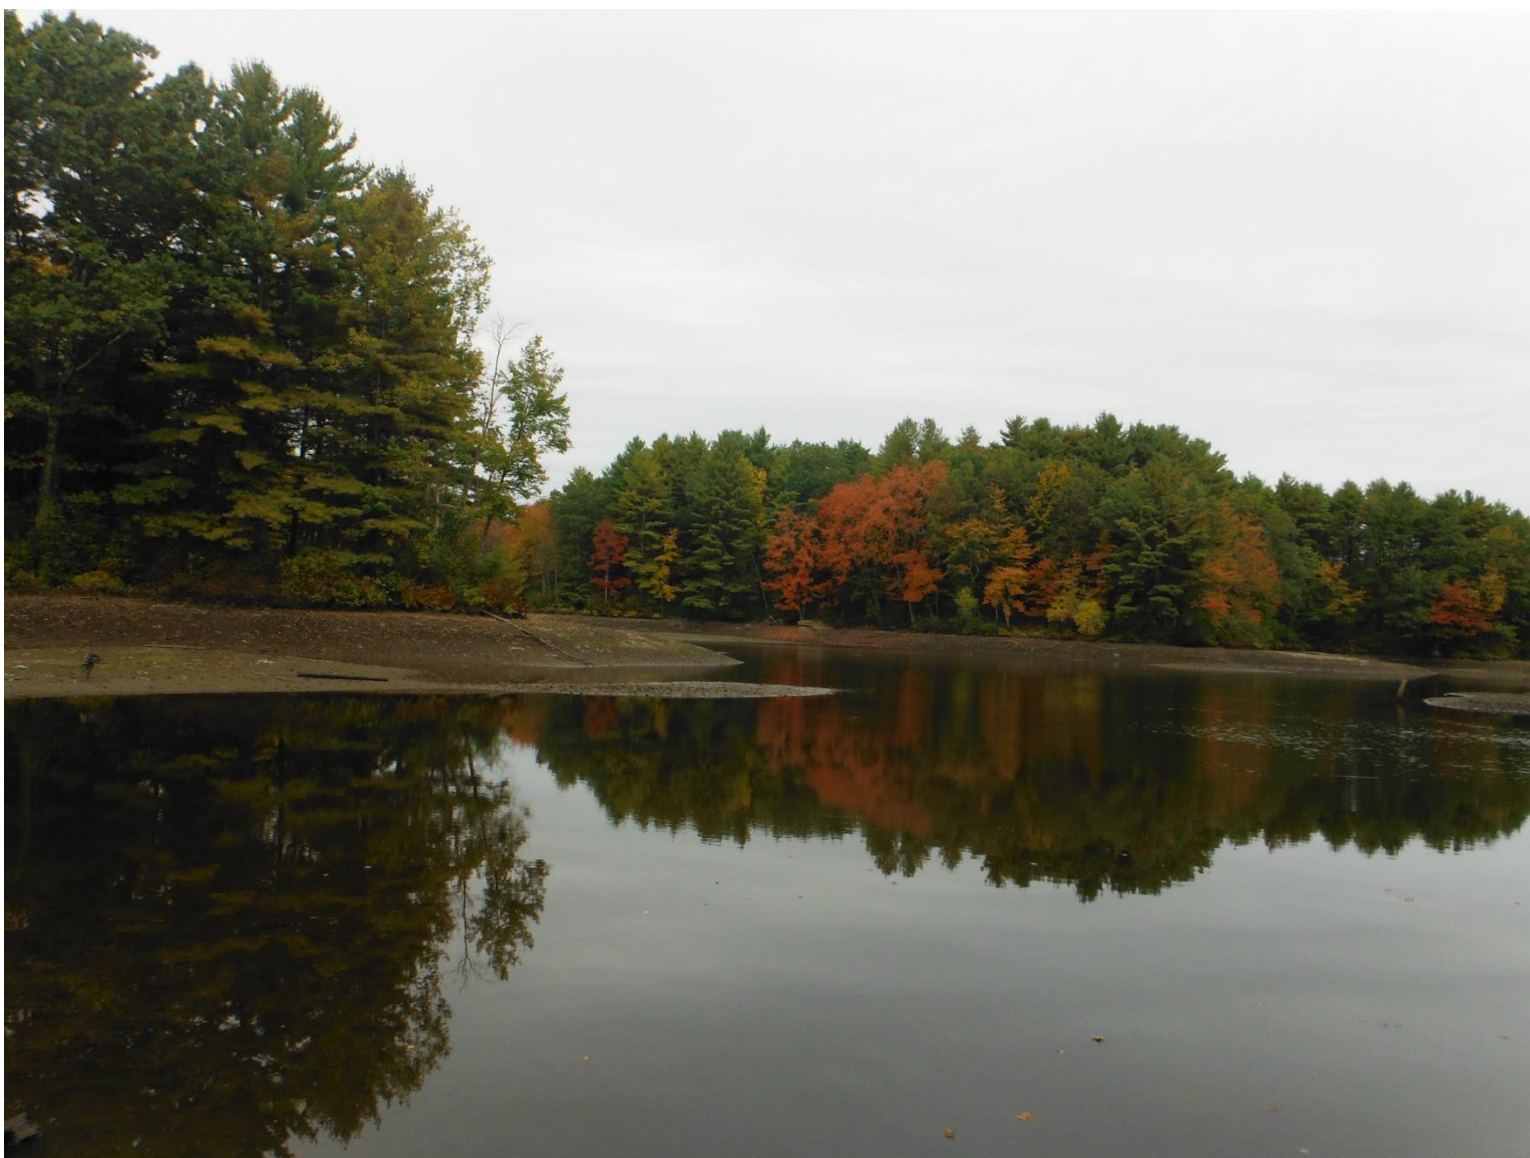
Figure E-6: Downstream-looking view of the Piscassic River from the Piscassic boat launch. Photograph taken 10/5/2013.

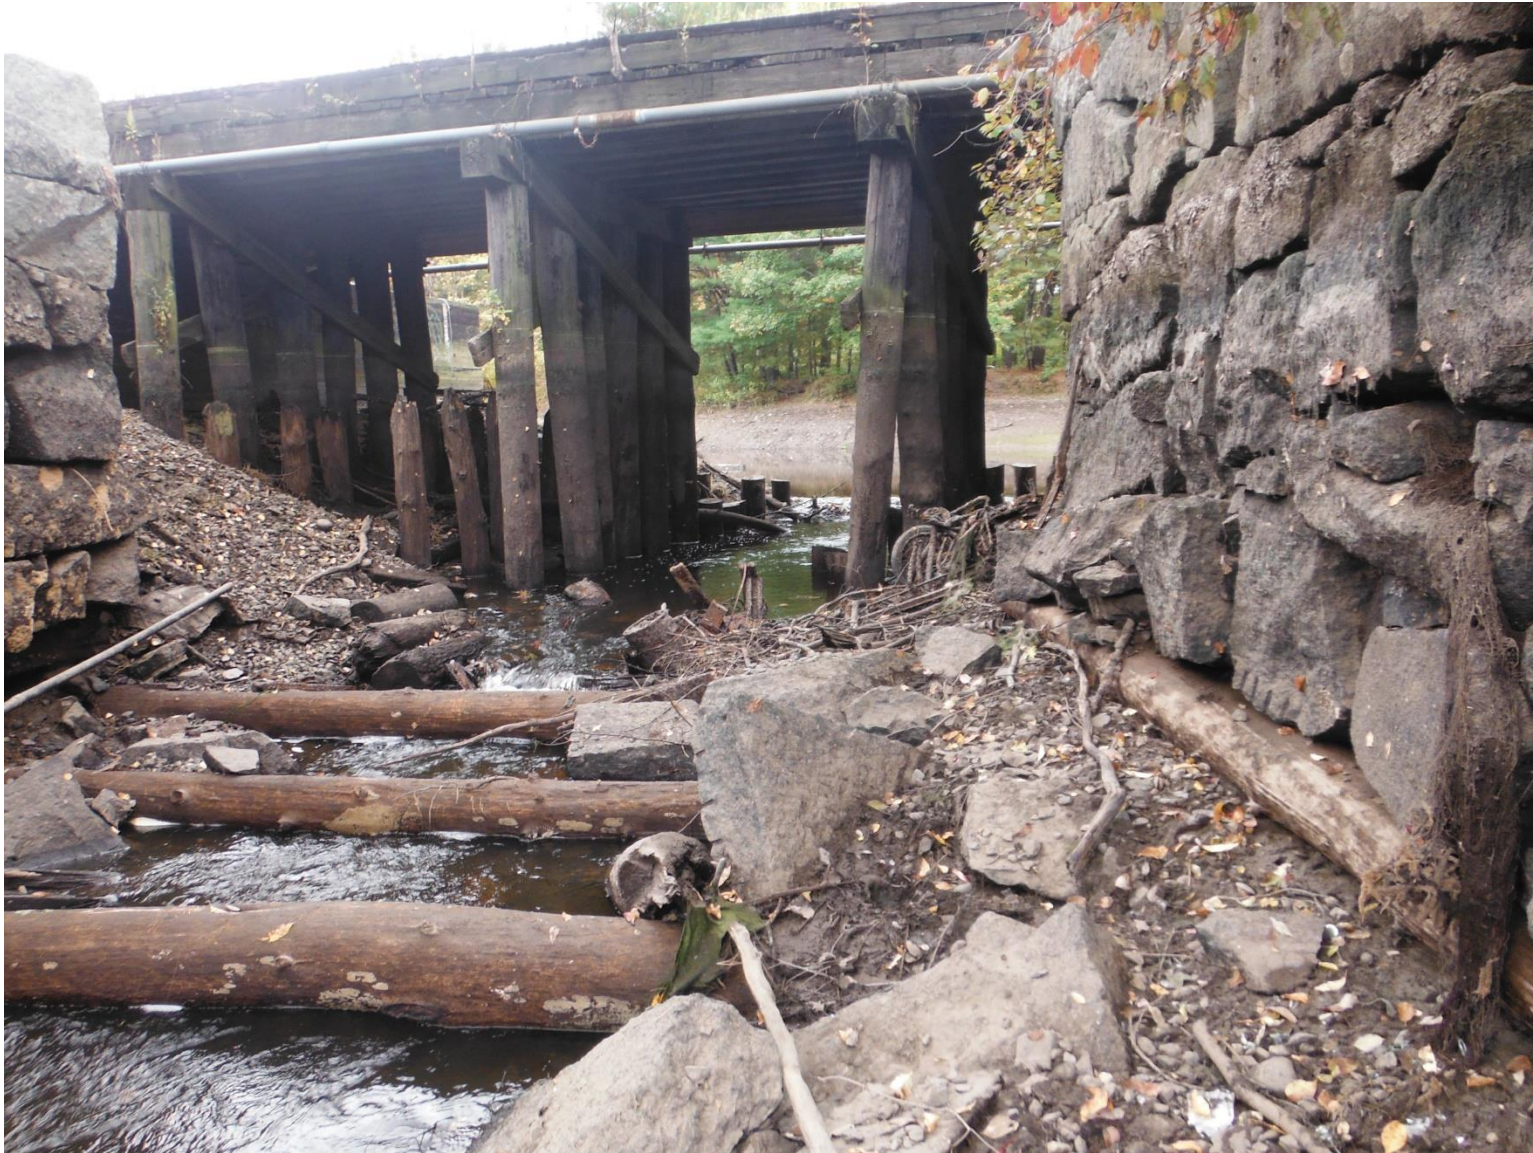
Figure E-7: Looking upstream at the Piscassic railroad bridge. Photograph taken 10/5/2013.

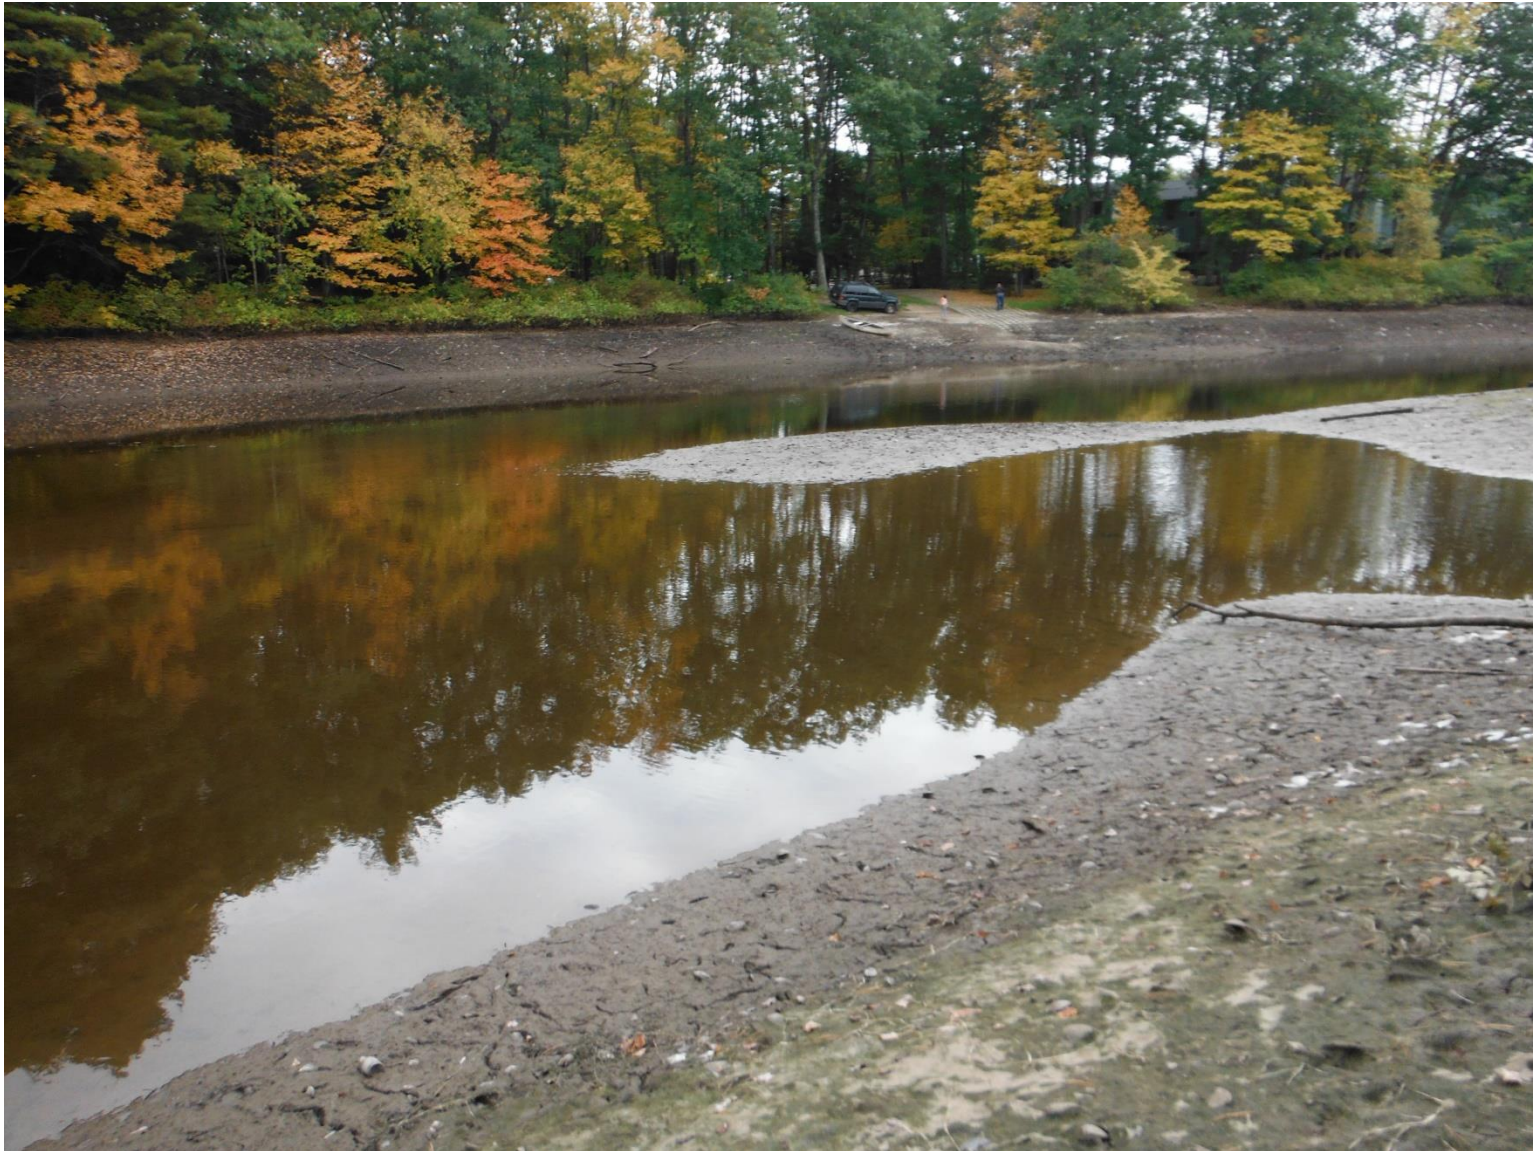
Figure E-8: Looking upstream at the Piscassic boat launch. Photograph taken 10/5/2013.

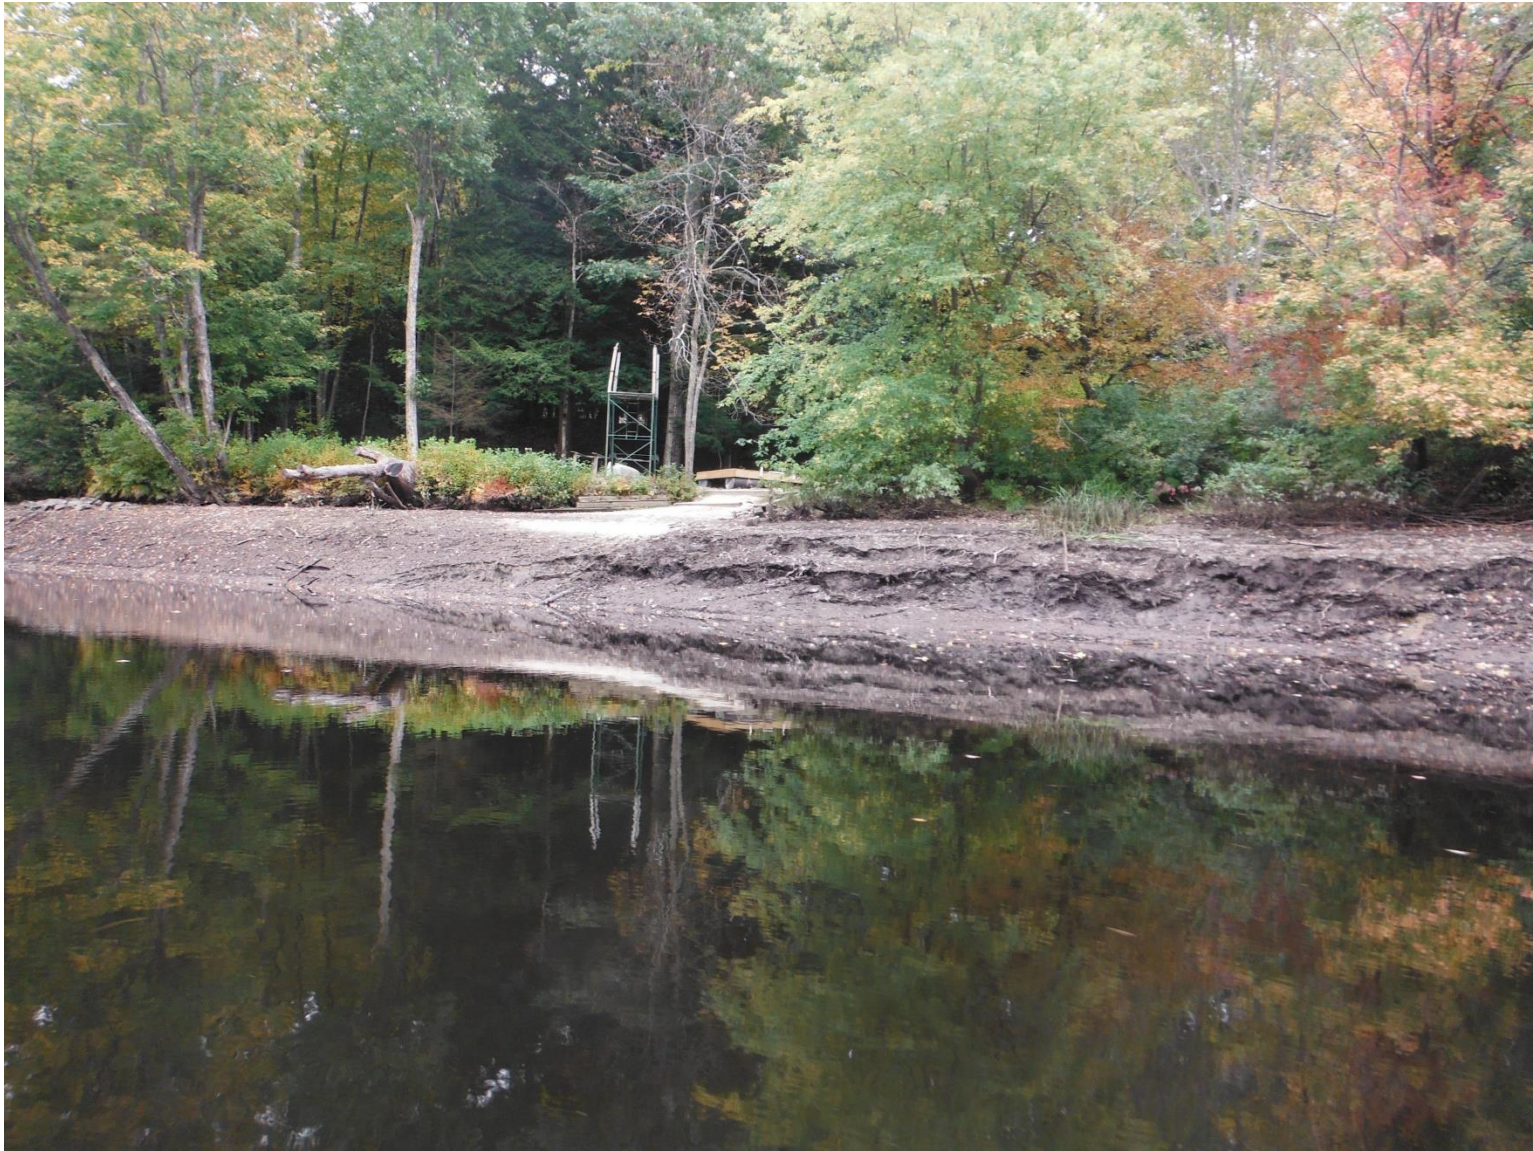
Figure E-9: Sloughing portion of riverbank between Moat Island and the Piscassic confluence. Photograph taken 10/5/2013.

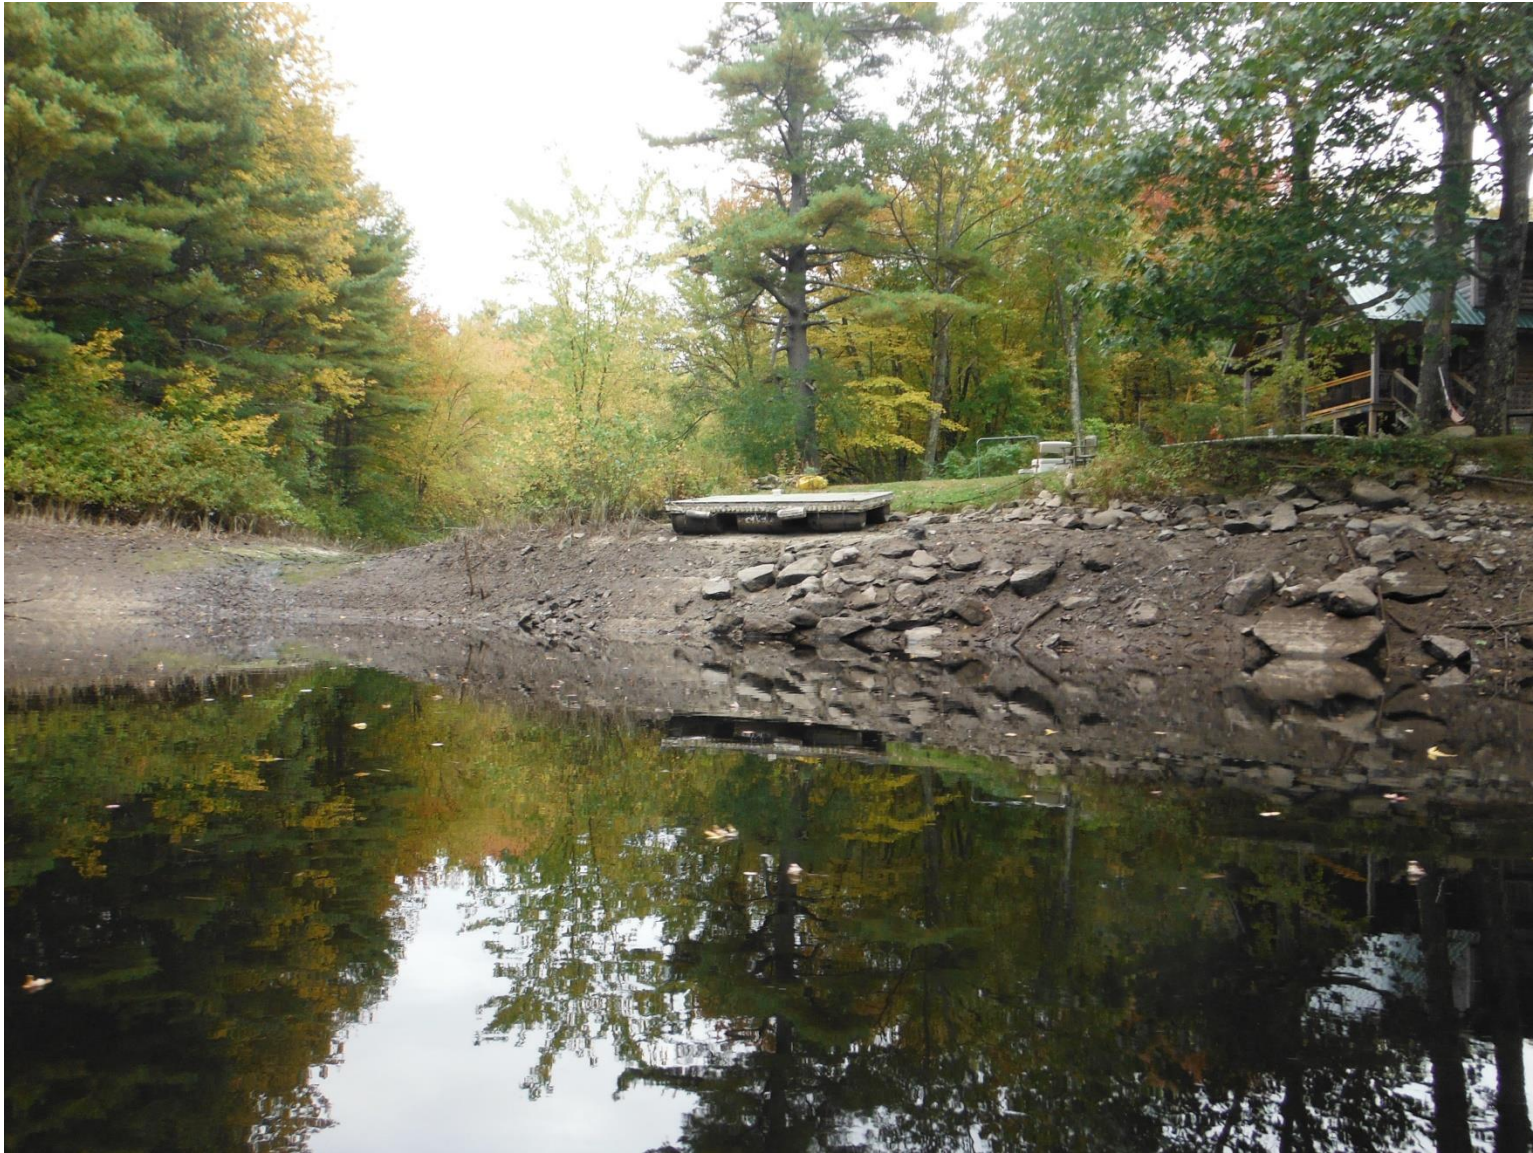
Figure E-10: View of resident's dock in dewatered portion of bank. Photograph taken 10/5/2013.

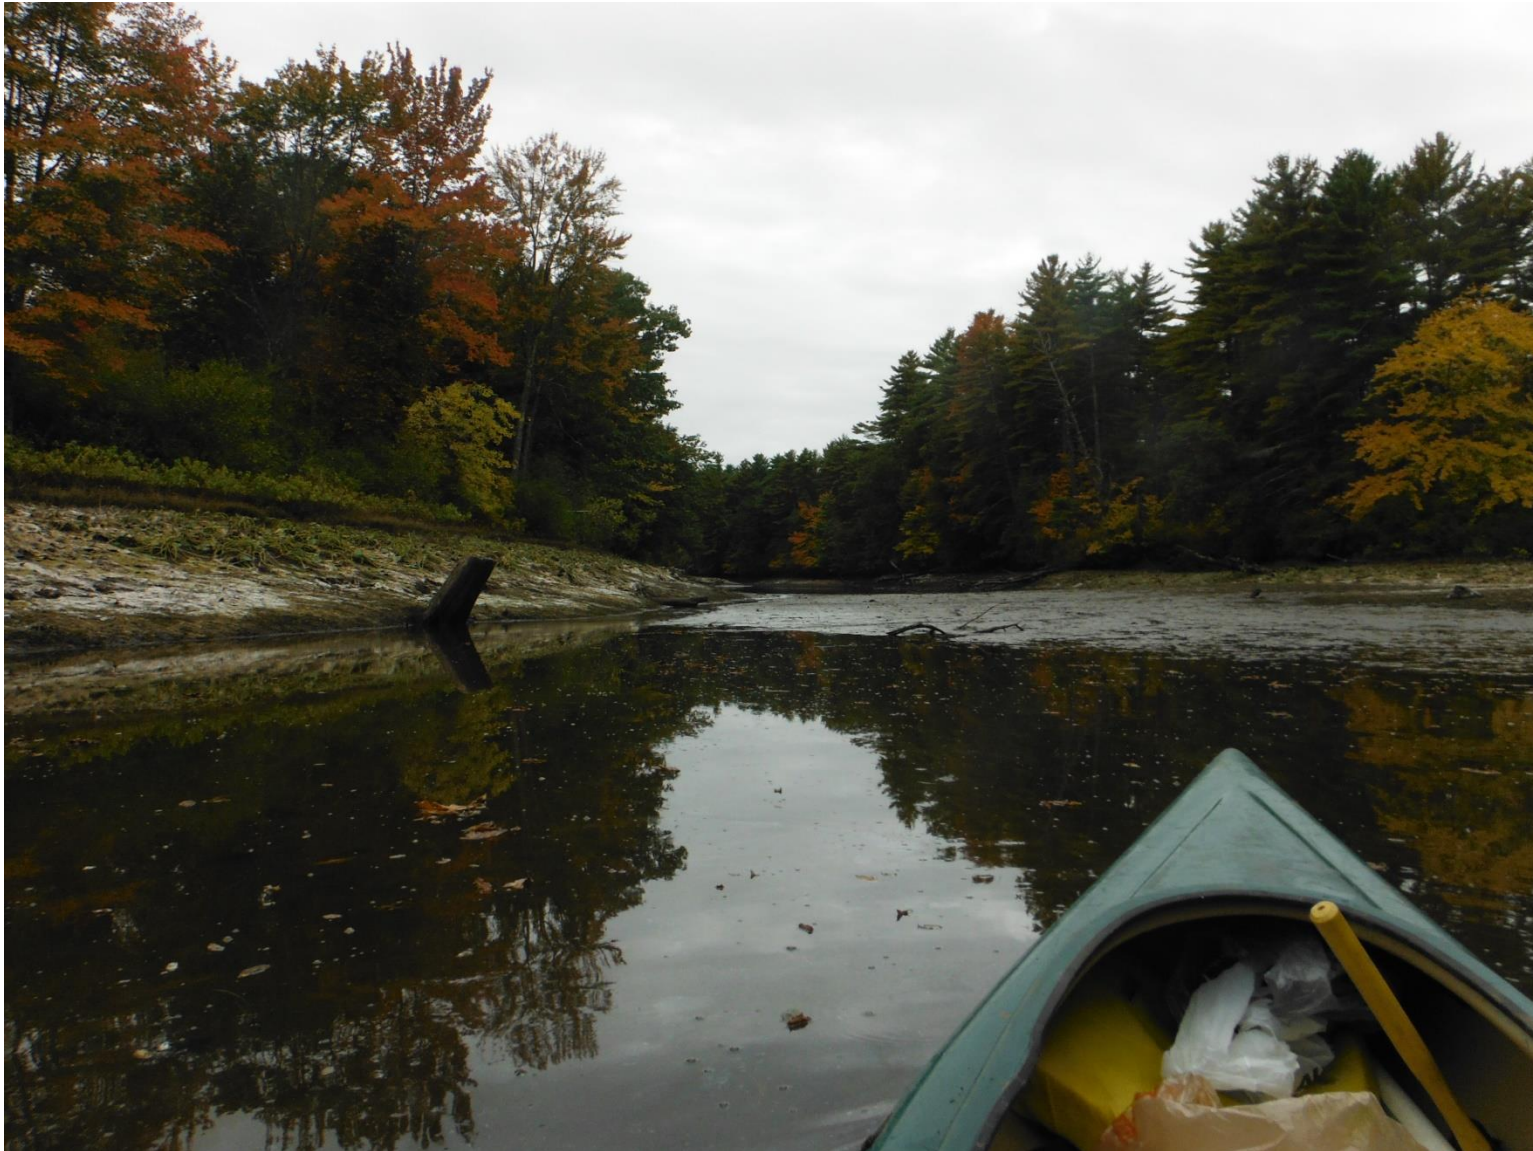
Figure E-11: Upstream navigation extent of Moat Island reach. Photograph taken 10/5/2013.

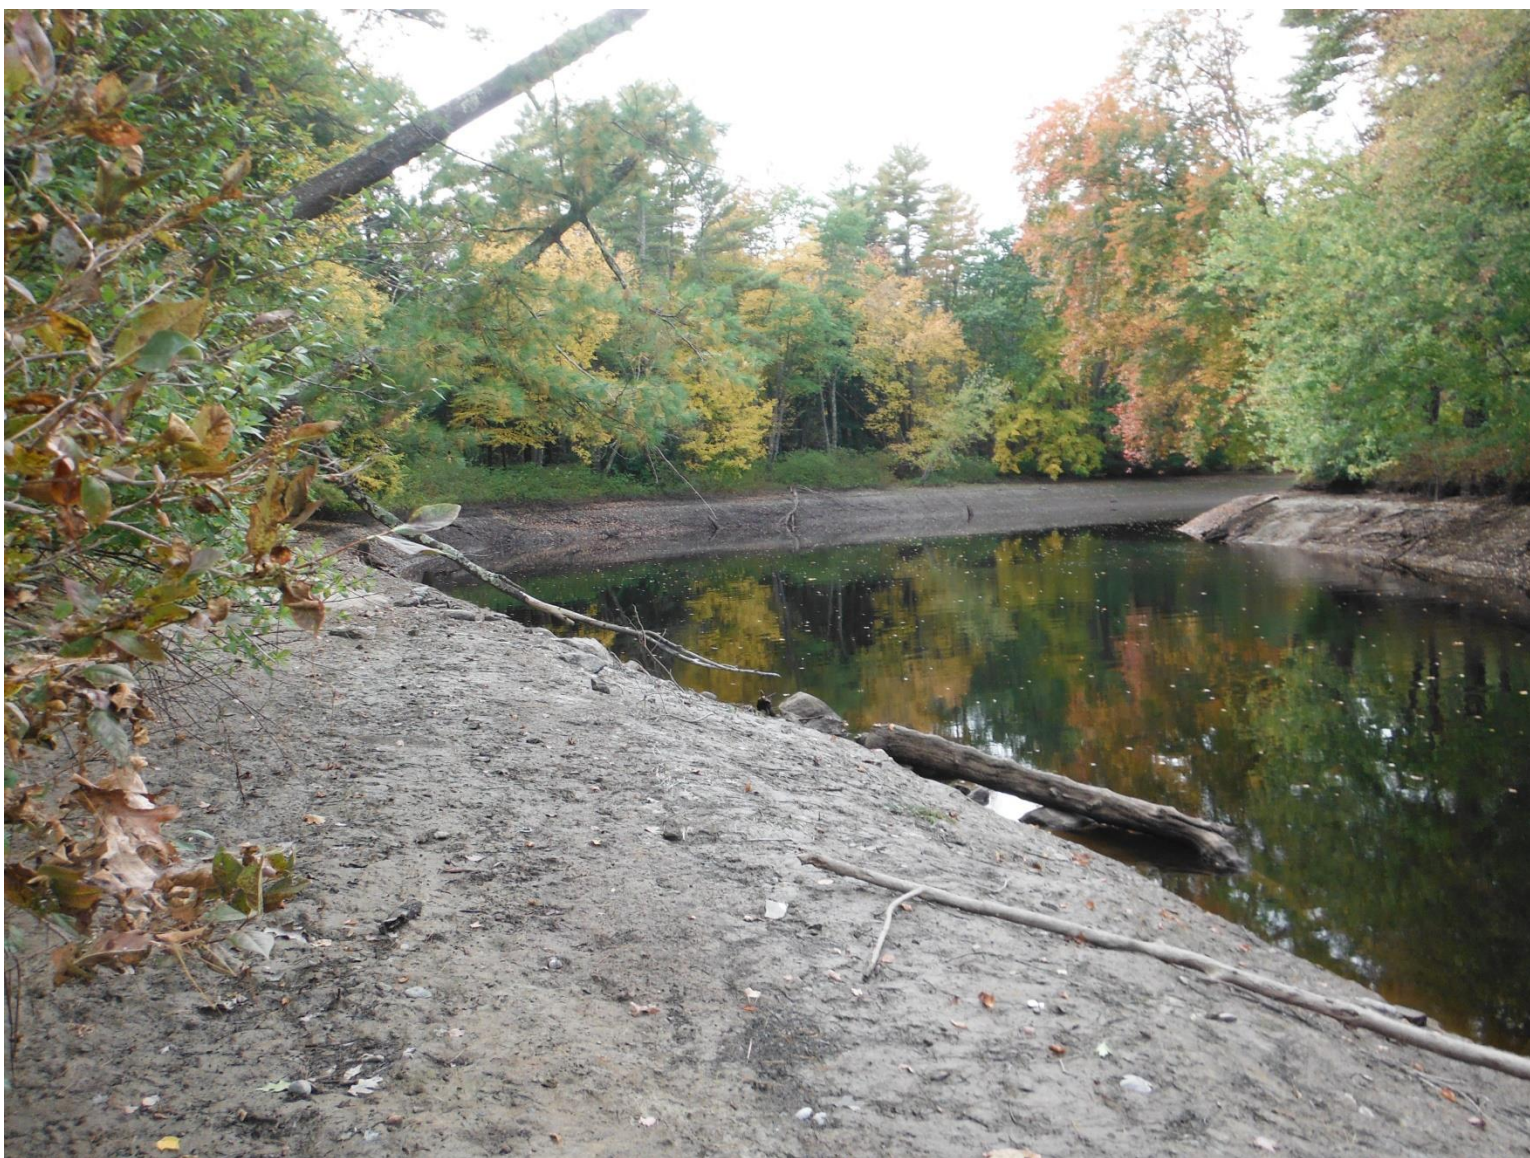
Figure E-12: Upstream-looking view of Lamprey River upstream of Moat Island confluence. Photograph taken 10/5/2013.

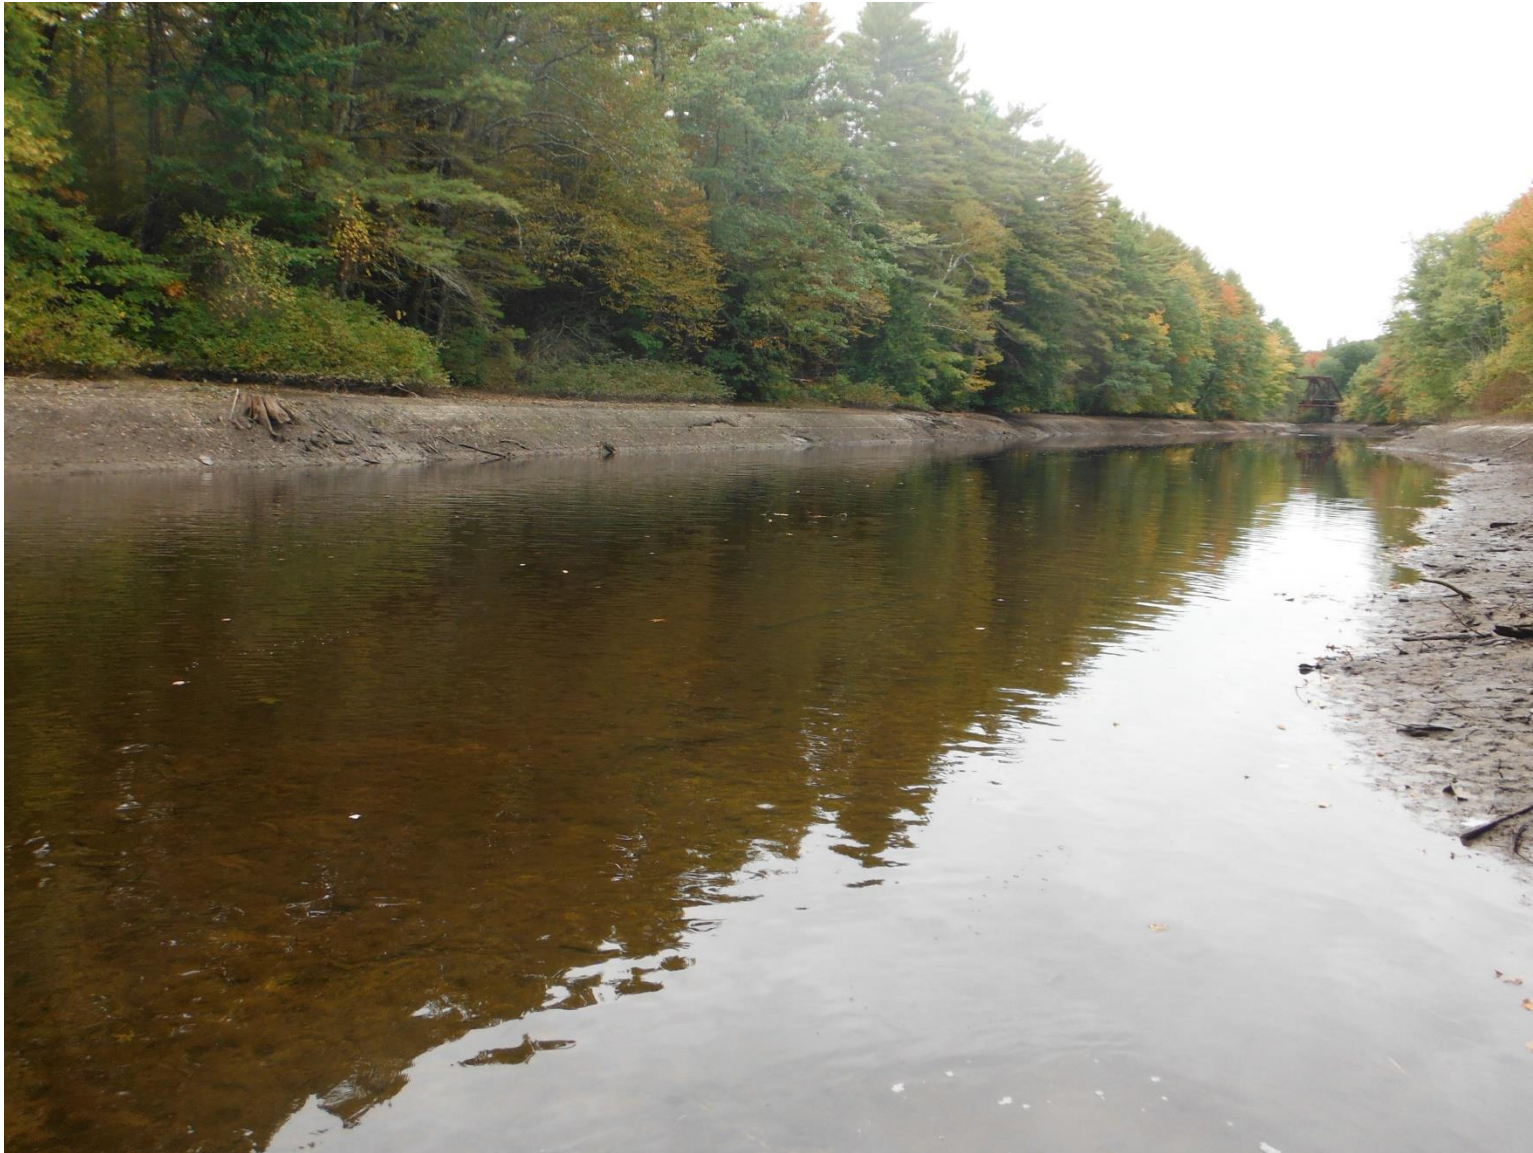
Figure E-13: Looking upstream at shallower reach downstream of Lamprey railroad crossing. Photograph taken 10/5/2013.

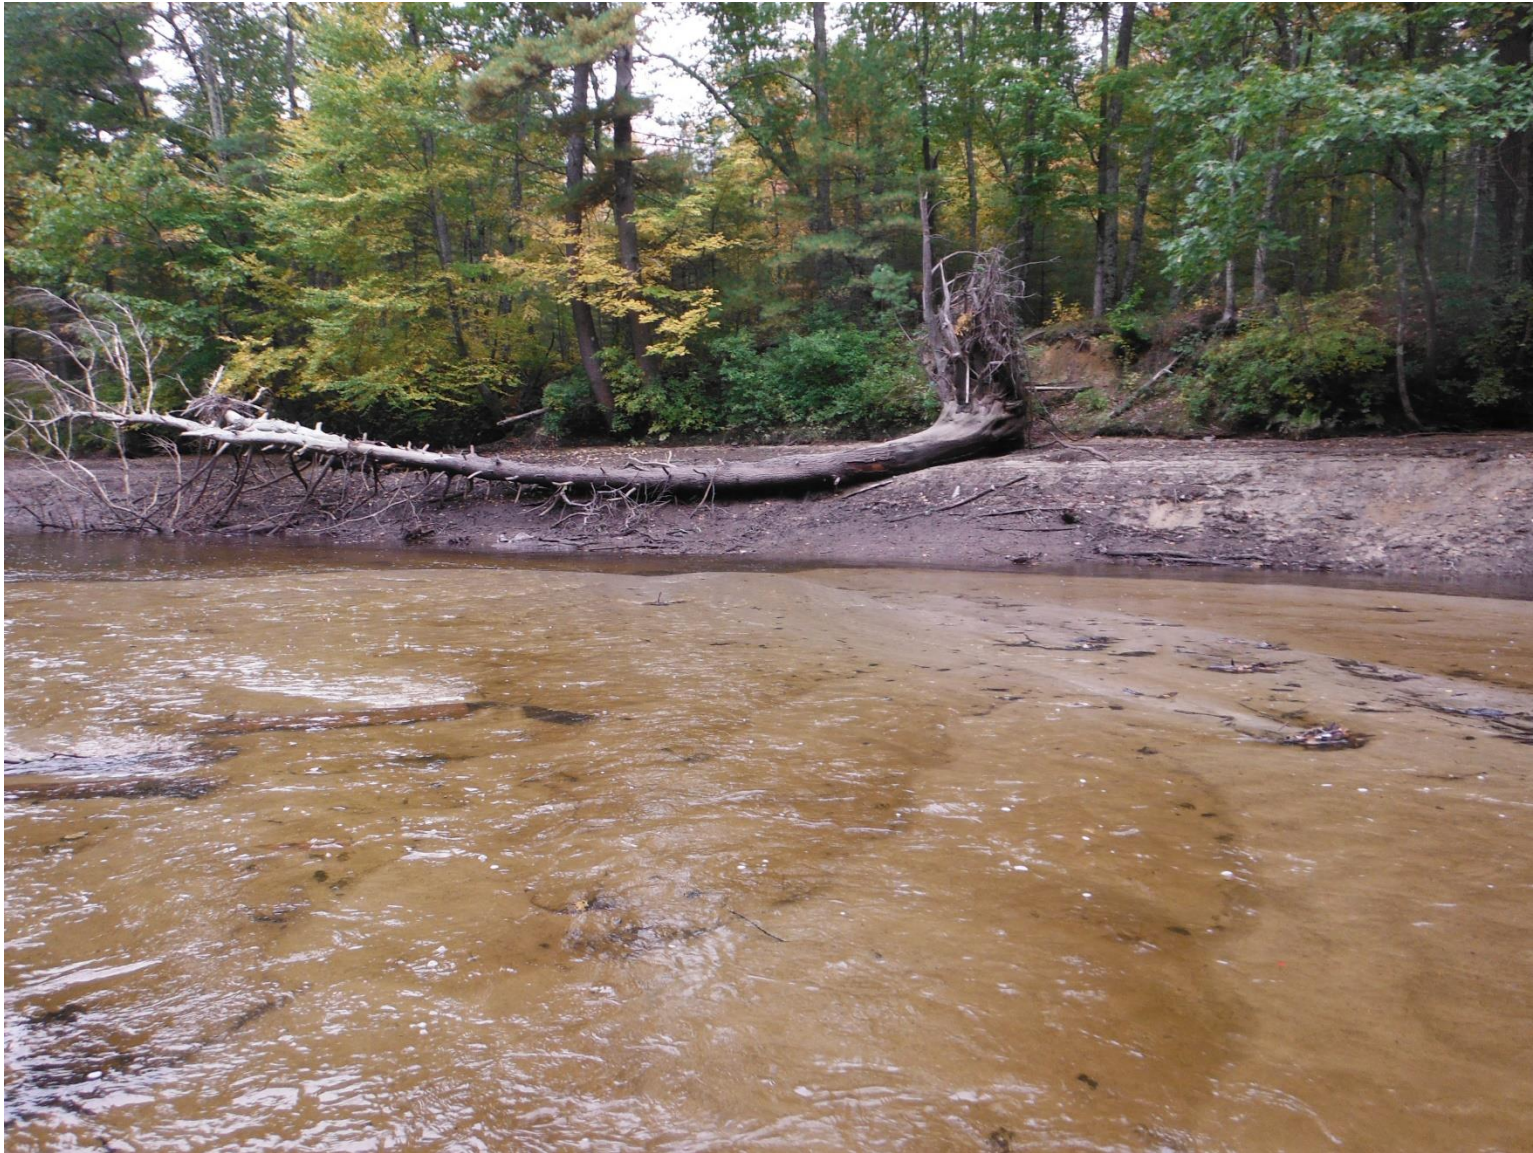
Figure E-14: Shallow riffle section downstream of pool near Packer's Falls. Active erosion noticeable. Photograph taken 10/5/2013.
